Cane Creek and Little Cane Creek Watershed Management Plan to Address E. Coli Impairment, Oconee County, SC

September 2018 (Rev. January 2020)

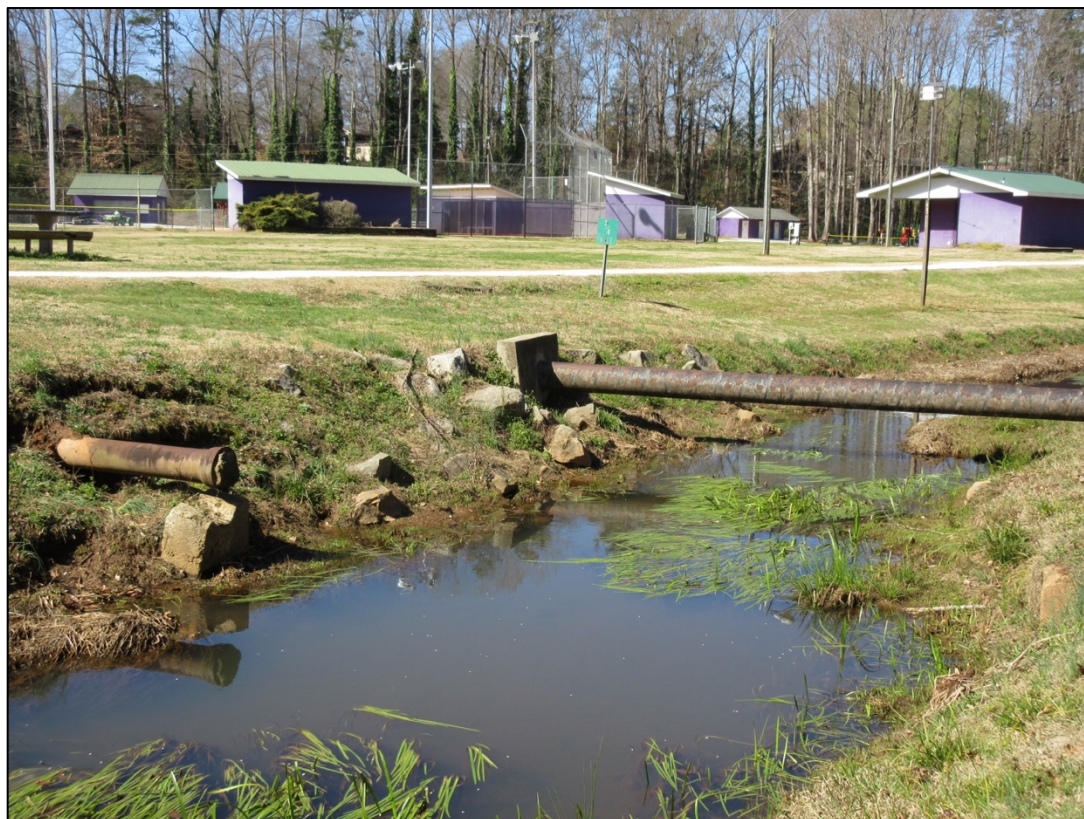
Fig.18. Previously sealed and replacement sewer lines hover just a few feet over unnamed tributary leading to Cane Creek, which runs through Sertoma Field, Walhalla, SC.

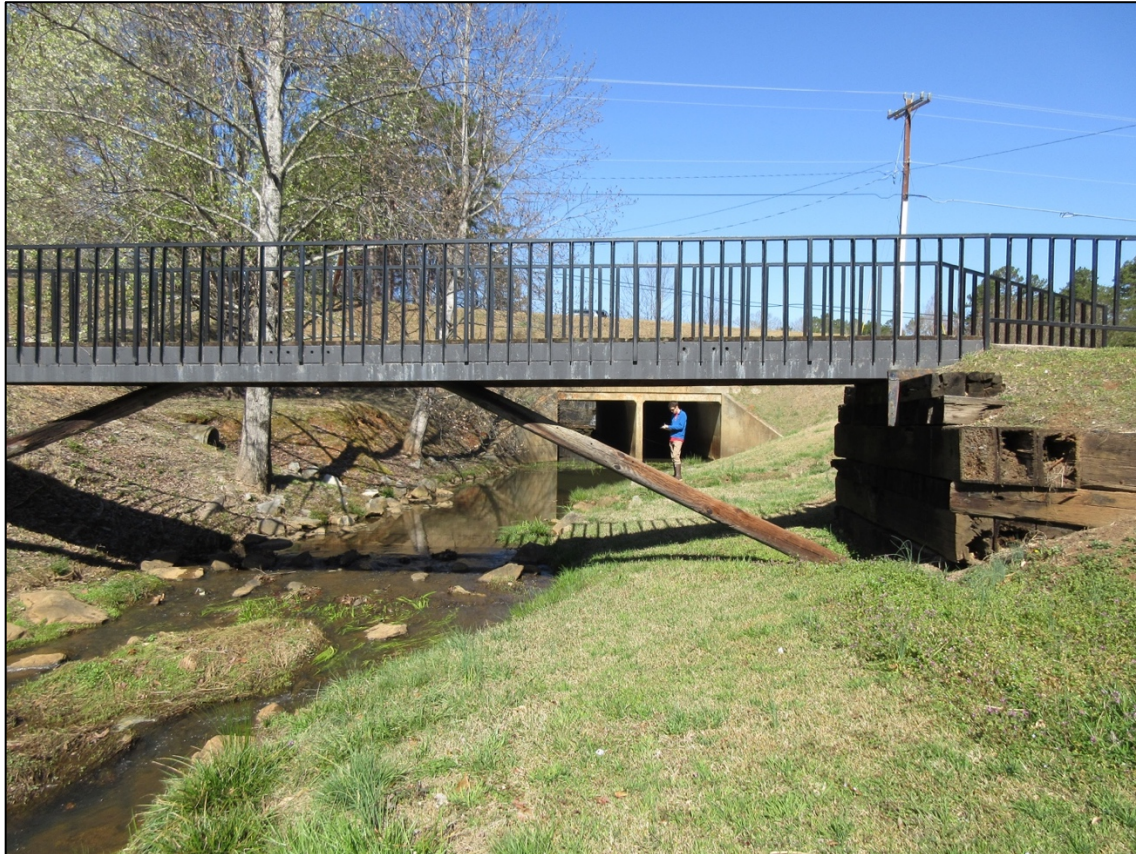
Fig. 19. Tributary to Cane Creek from neighborhood pond, after it passes under Highway 183 and enters into Sertoma Field.

length and for the majority of the year. The tributary is shaded by a few large trees, but predominantly has turf extending to the edge of the low bank (Fig. 19). Though not observed during the development of this watershed plan, stakeholders have stated that this park and adjacent parking lot floods several times per year. The adjacent parking lot is not curbed and is at a distance between 15 and 30 feet from the tributary for its full length. The opposing side includes utilities, walking path, and turf to the edge of the waterway (Fig. 20).

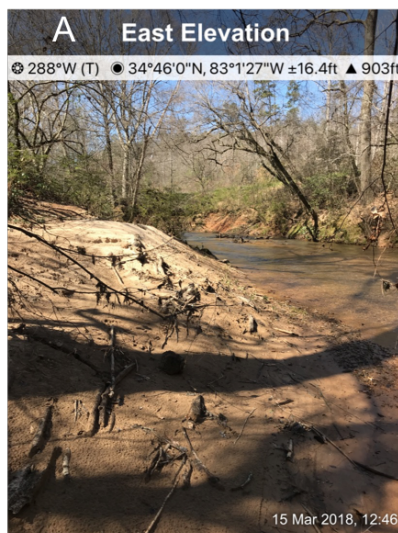
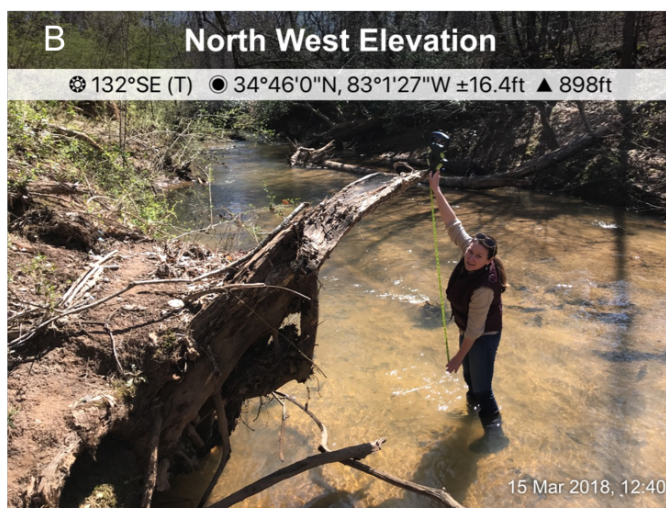
Reach of Cane Creek showing A) Sediment deposition along channel bend; B) Downed tree; C) Space left by downed tree and sediment available for stream bed deposition

Fig. 23. Pictures of lower Cane Creek displaying the repeated cycle of trees on the cusp of collapsing into the stream, sediment accumulation, trees already have fallen into the stream, and vulnerable sediment for deposition.

Given the characteristic failing of large trees in the stream corridor, the incurred deposition of sediment due to bank loss, and the accumulation of sediments in the stream bottom, it is believed that this series of events, paired with a regular input of fecal polluted runoff or leachate is a significant cause of the observed bacteria impairment frequency in the surface waters of Cane and Little Cane Creek near their DHEC monitoring stations (see Fig. 23).

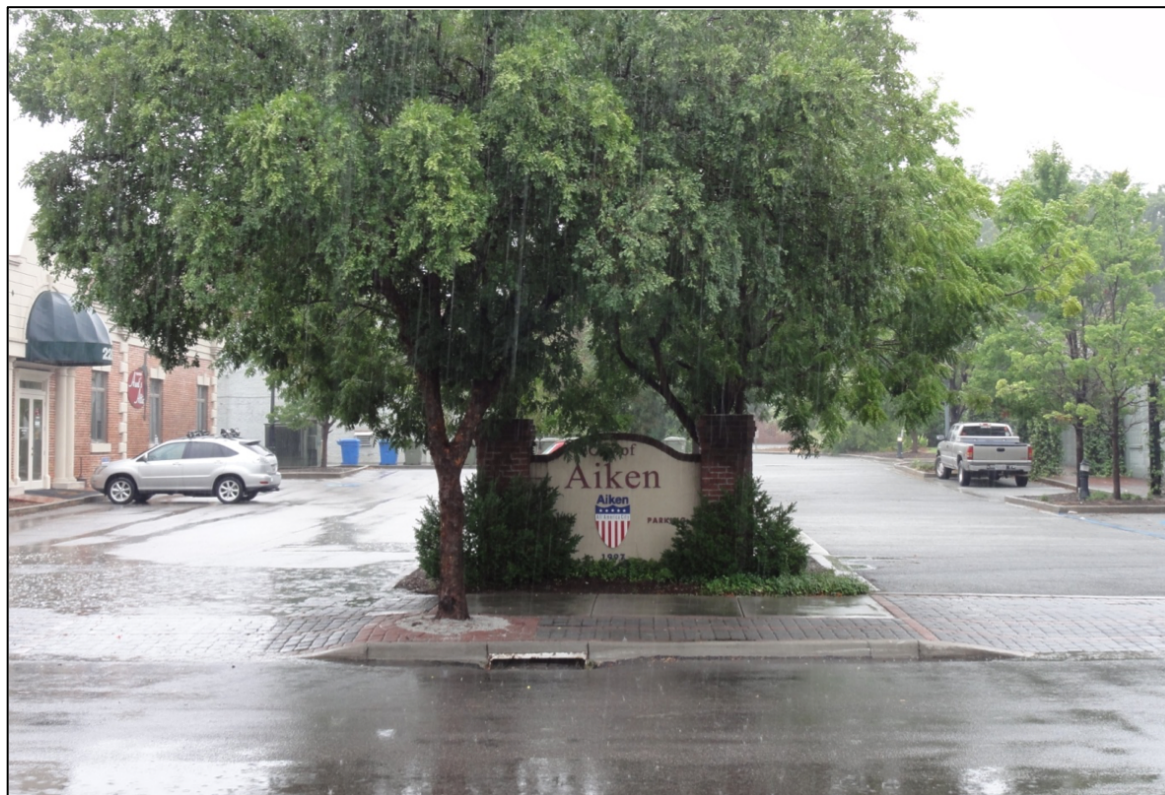
Fig. 28. This image from Aiken, SC demonstrates the ability of a porous asphalt road (right) to quickly infiltrate rain water, in comparison to standard asphalt road (left) showing puddles (Source: Calvin Sawyer, Ph.D., Clemson University).

While the porous asphalt is being installed, stormwater infrastructure should be eliminated along the parking lot and collected from Tulip Drive, which is perpendicular to the park road. With the porous asphalt in place, this stormwater will be more effectively treated than traditional pipe collection (Fig. 28).
